Archeological Testing
Cinder Block Garage
112 East Leigh Street
Maggie L. Walker National Historic Site
Richmond, Virginia

Allen H. Cooper
Mid-Atlantic Regional Office
David G. Orr
Division of Archeology and Historic Architecture
Valley Forge National Historical Park
National Park Service
1995

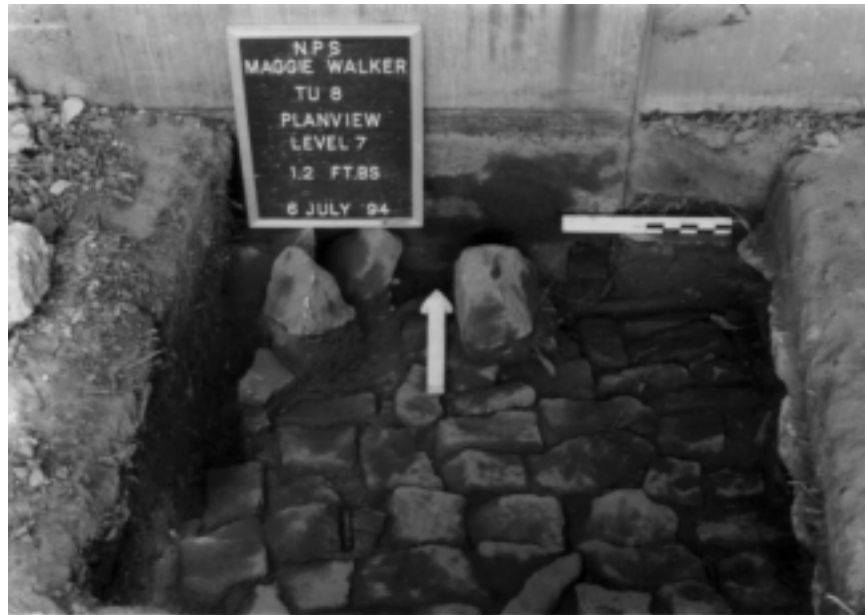
The feature consisted of randomly placed stone rubble mortared to a sloped rectangular concrete slab located 0.6 feet below ground surface and 0.5 feet away from the structure (Figure 2). To evaluate the spatial extent of this feature and to confirm its function, a single test unit was excavated between the existing south door and the southeast corner of the garage (Figure 1). If this feature was intended for drainage, then it should continue along the entire length of the wall, traversing the location of the test.

Figure 2: Photograph of stone rubble feature.

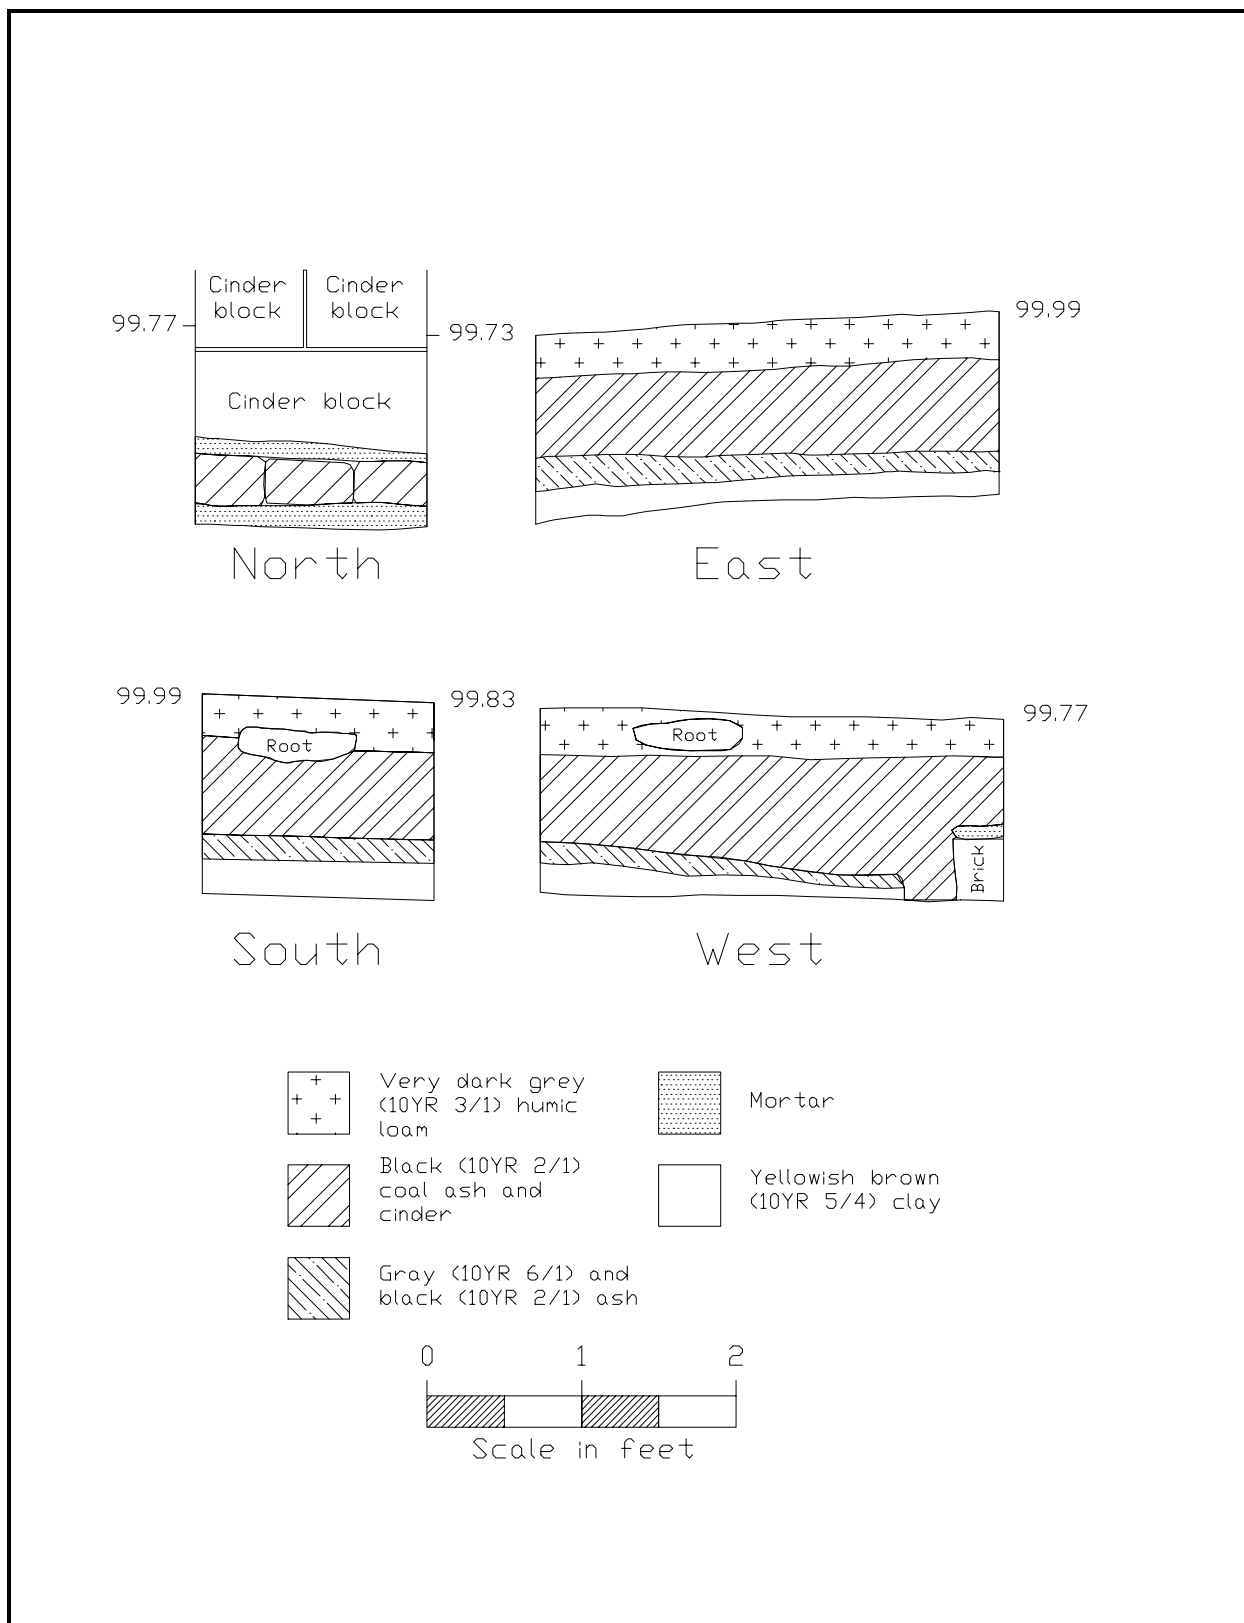
Excavations revealed four distinct strata reflecting those observed in Test Units 5 and 8 and elsewhere in the site (Figure 3). The feature identified in those units, however, was markedly absent as was any sign of its removal.

Stratum two consisted of black (Munsell color 10YR 2/1) coal ash and cinder extending from 0.4 to 1.3 feet below surface. This layer is deeper where it forms the builder's trench for the garage's foundation. This layer is impacted by construction of the foundation only on the west wall. Its width is insufficient to account for removal of the drainage feature observed in Test Units 5 and 8.

Stratum three consisted of black (Munsell color 10YR 2/1) and gray (Munsell color 10 YR 6/1) ash approximately 0.15 feet thick. Like Stratum two, it is impacted by the builder's trench for the garage in the west profile.

Figure 3 Profile drawings of test unit.
